Cherokee National Forest Landscape Restoration Initiative

Paint Creek Watershed Team

Site Assessment Survey

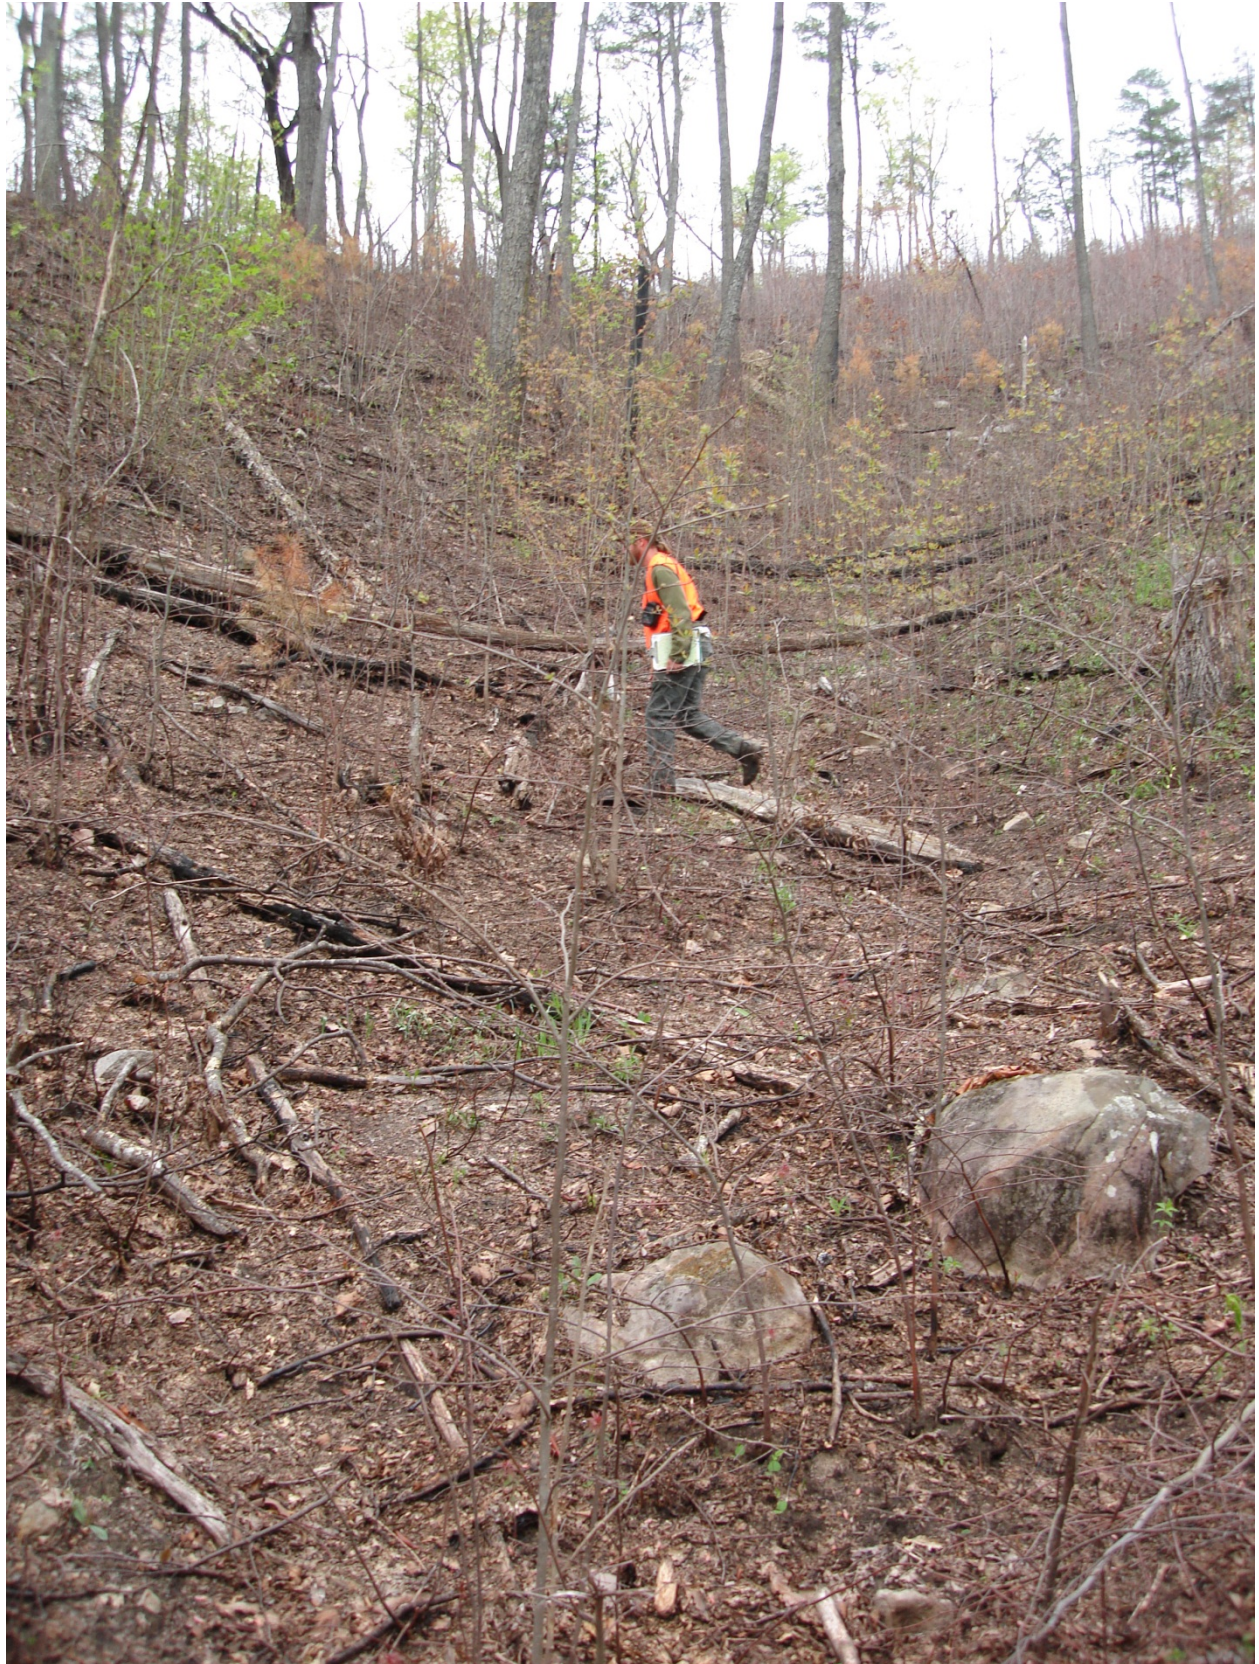
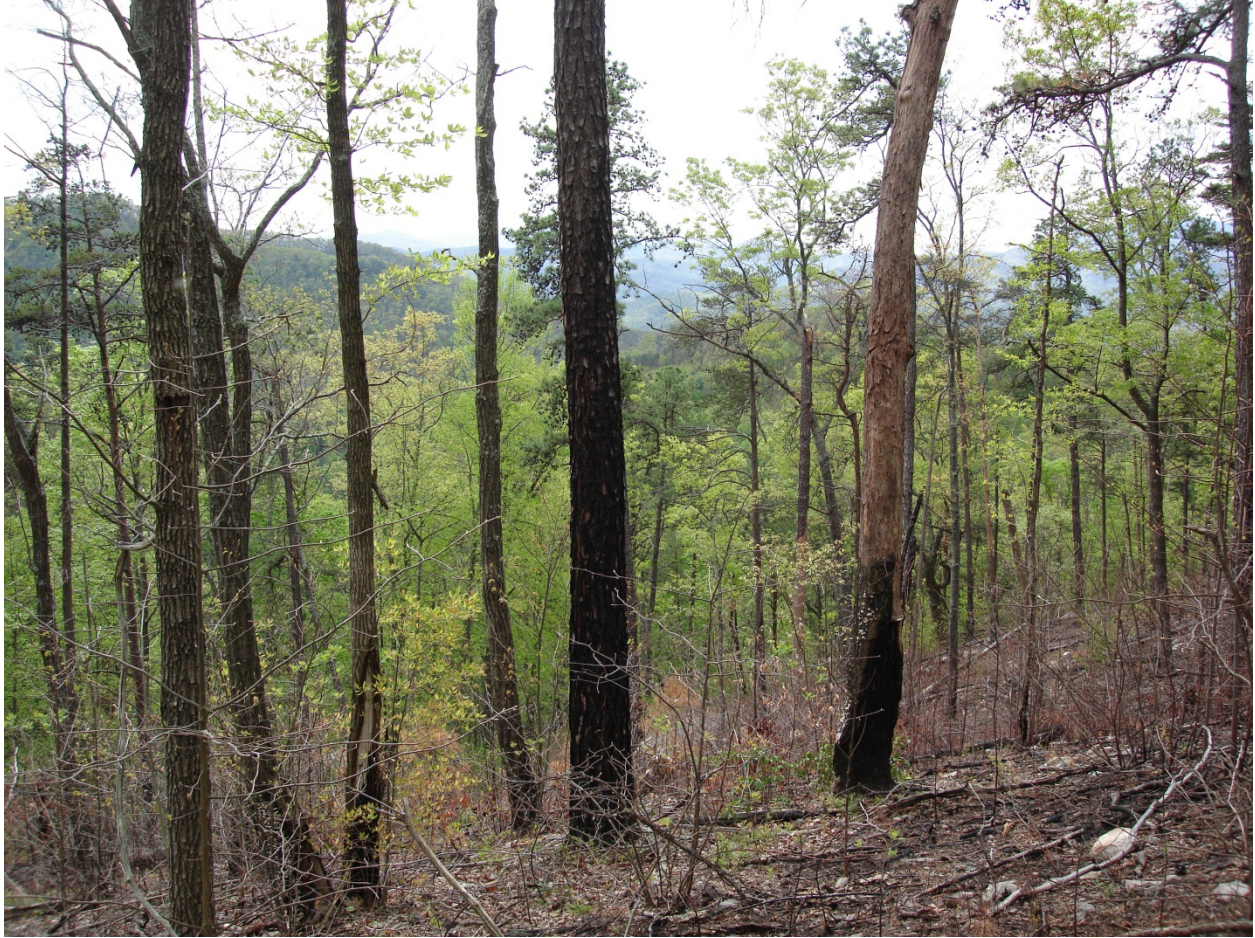
Site Number (date and chronological order)	4.10.12 Site 2
FS Veg Compartment and Stand Number	223-3
Approximate Elevation	About 2,100-2400
Slope	Mid-slope to ridge
Aspect	South
What is the current Ecological system present at the site?	Chestnut Oak, Scarlet Oak, pitch pine, table mountain pine, shorleaf pine, Virginia pine, black gum
What does FS Veg say is the current Forest Type?	38 Pitch Pine
What did Steve Simon's model predict would be at the site?	Pine dominated oak
Is the site in a desired condition? Could it be improved? What S-Class or System would we like to move it toward?	Yes. It was recently burned (Cummins Branch Burn) and it is in an open Oak/Pine condition.
What treatment options could be used to do that? How many entries?	
How many of those treatments could be done commercially?	
Would there be a need for additional funding to complete treatments at this site?	
Does this site provide an opportunity to demonstrate a restoration treatment or condition that is better than other locations in the watershed? On the north end of the Forest?	Good example of early and open oak/pine condition

Additional Comments/Discussion Points or unanswered questions.	This site afforded good discussion about fire as a tool for restoration and also about when management might switch to maintenance burns. What would the frequency be?
