Cherokee National Forest Landscape Restoration Initiative

Paint Creek Watershed Team

Site Assessment Survey

| Site Number (date and chronological order) | 7.11.12 Site 1 |

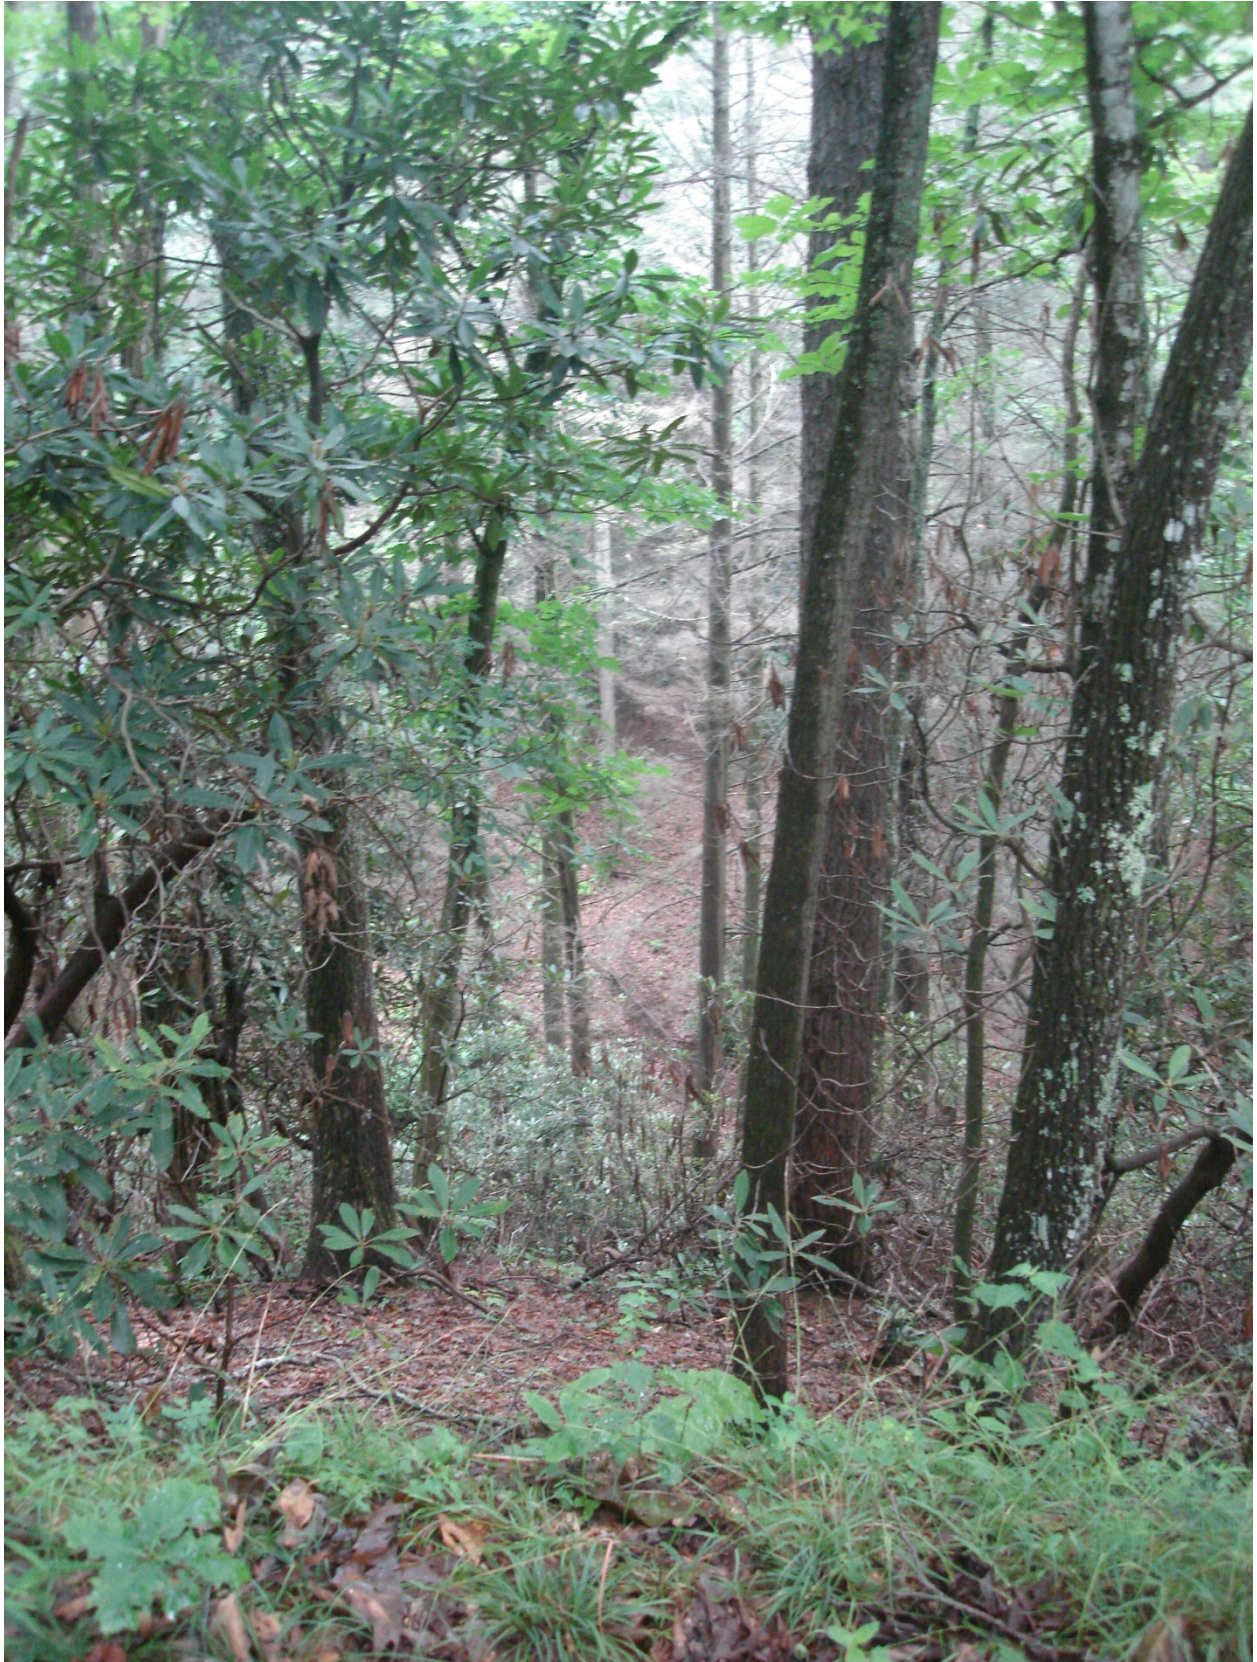
Stand 25 Viewed from Hurricane Gap Road

| Additional Comments/Discussion Points or unanswered questions. | 25- Very Steep. May only be suitable for cable logging. |

| Is the site in a desired condition? Could it be improved? What S-Class or System would we like to move it toward? | 24- Continued burning to reduce white pine regeneration. 25- Diverse hardwood mix already present. Only Treatment might be to remove some of the Poplar. |
| What treatment options could be used to do that? How many entries? | 24- Prescribed Fire 25- Thinning |
