Cherokee National Forest Landscape Restoration Initiative

Paint Creek Watershed Team

Site Assessment Survey

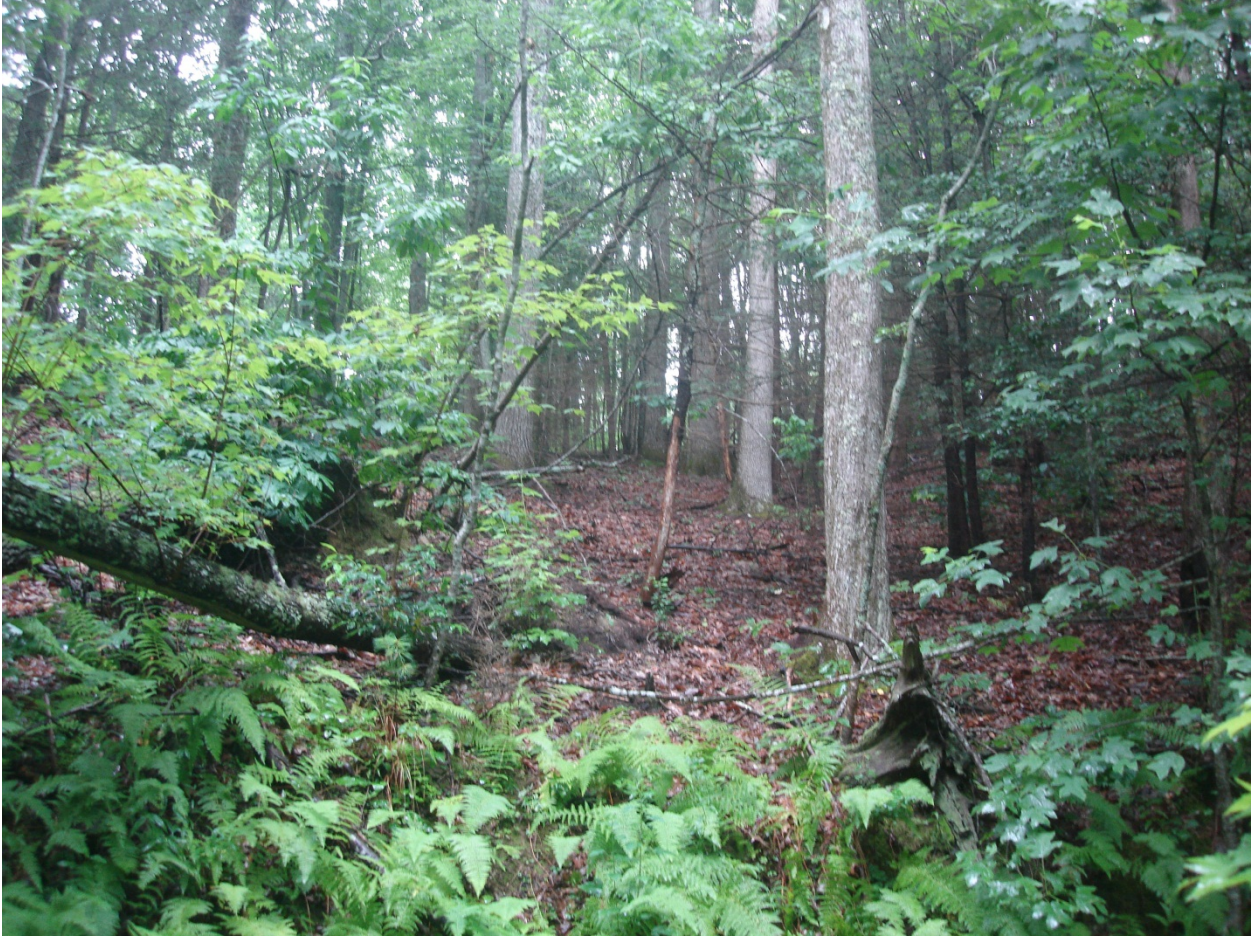
View upslope from Saw mill branch road

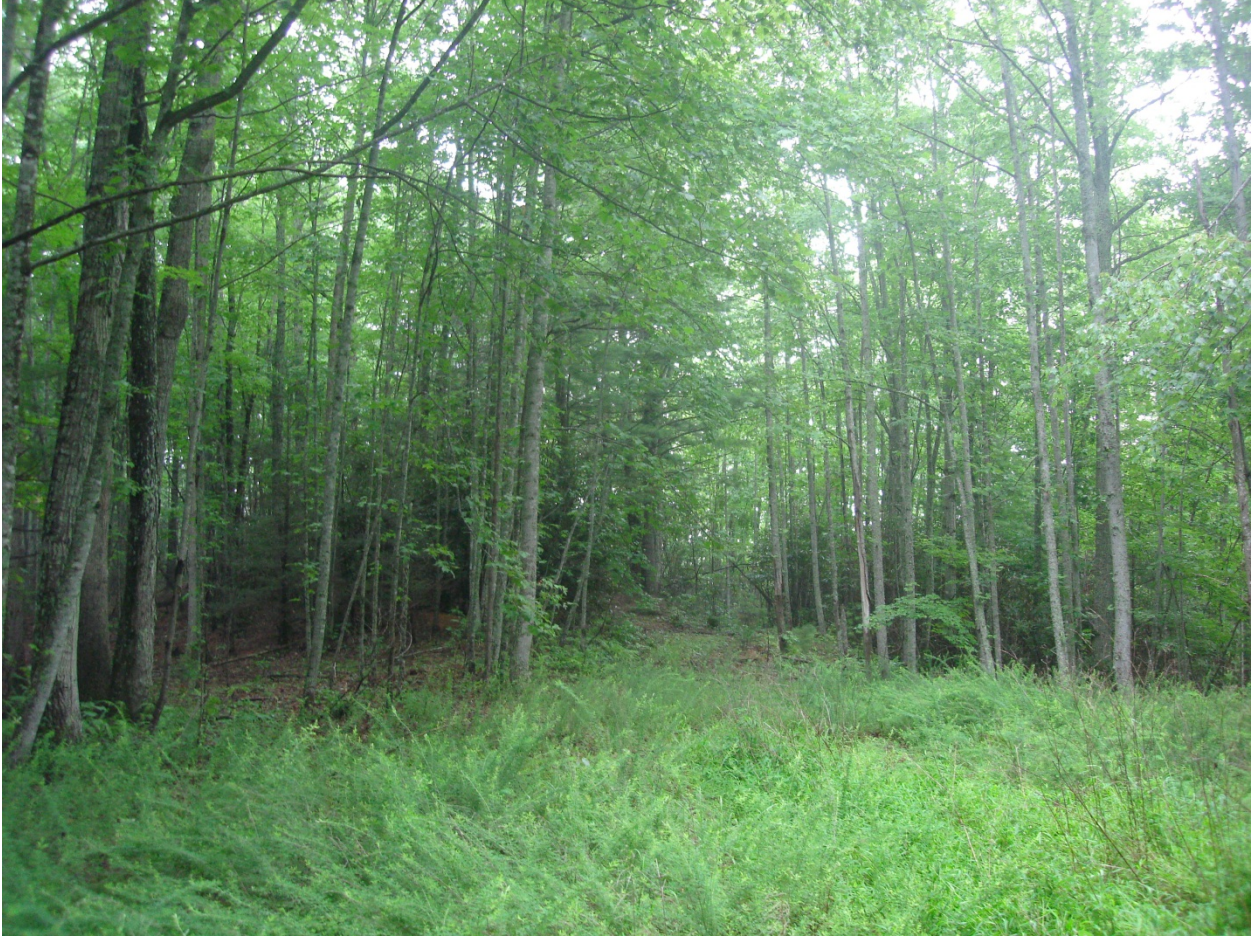
View from Saw Mill Branch road
